RE: Letter received from MECP dated June 10, 2021

A letter was received by Vale on June 10, 2021 sent by the Ministry of Environment, Conservation and Parks (MECP) via email. This letter was a continuation of the cooperative interaction between the MECP and Vale to progress the Port Colborne Community Action Plan (PCCAP). The letter was discussed in a telephone conference, and the information and data discussed and viewed are now appended to this written report.

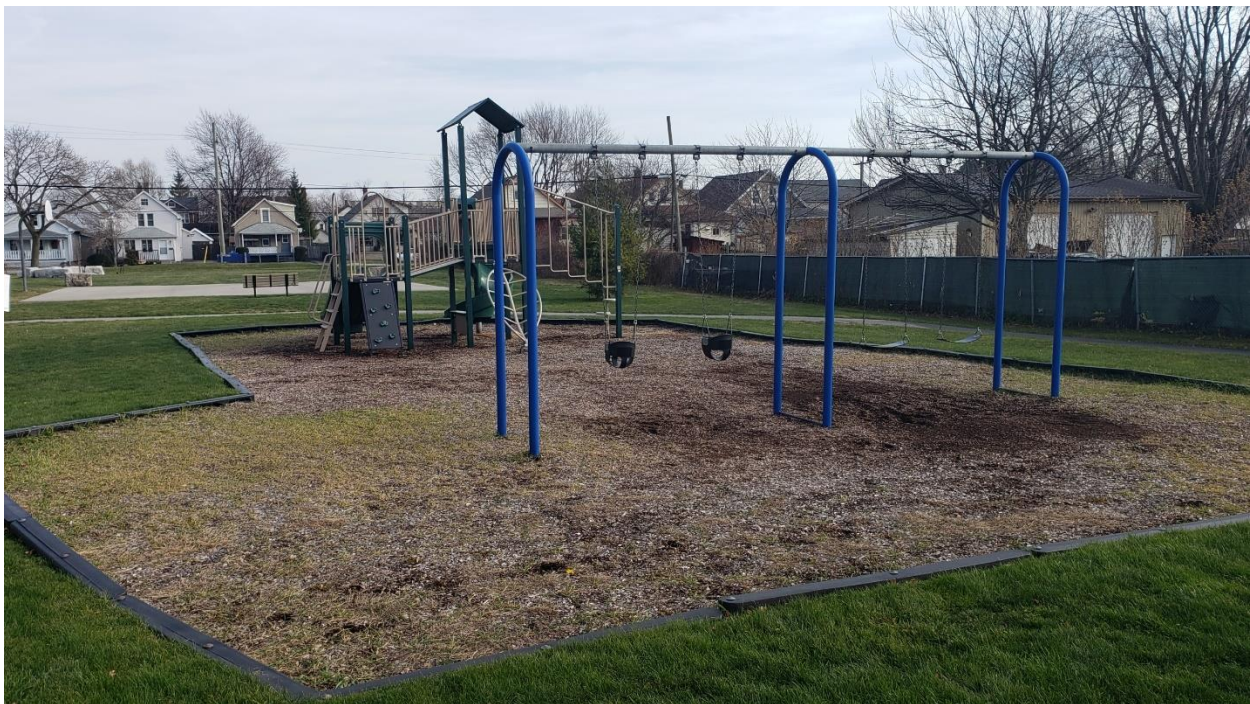
Picture A1 -East Village Park playground

This playground is located on Welland Street, north of Nickel Street. There is a substrate of woodchips on the playground surface, however it was observed that this is a relatively thin layer, that was easily moved to expose underlying soil. Through discussion with CPC staff it is believed that soil was imported during construction of the playground in 2007, however no construction details could be found. It is thought that the soil excavated for the playground forms the berm that is on the east side of the park, with imported soil being used to backfill prior to application of the woodchips. The area beneath the swingset was seen to have exposed soil most frequently. The CPC maintains this playground on a monthly basis or when a complaint is received. Additional maintenance occurs during the summer months when students are employed to remove weeds at parks. Playground maintenance includes the application of new woodchips or raking the surface to infill exposed soil areas.

In consultation with CPC, the playgrounds at East Village Park and Johnston Street Park are at the end of their normal service life. Vale has been in communication with the previous and the current Parks Managers as the City embarks on a Capital Replacement Plan for these two parks. Vale has requested to be informed of the CPC replacement decision so that there is opportunity for Vale to support initiatives

to reduce exposure to bare soils. Support could include excavation and backfill with new soil, or potentially using rubber or plastic mats in areas where soil exposure is common. As of July 2021, the CPC budget request for park capital costs is planned for 2022, however, Vale has offered its support for the existing playgrounds, as well as the potential redevelopment plans.

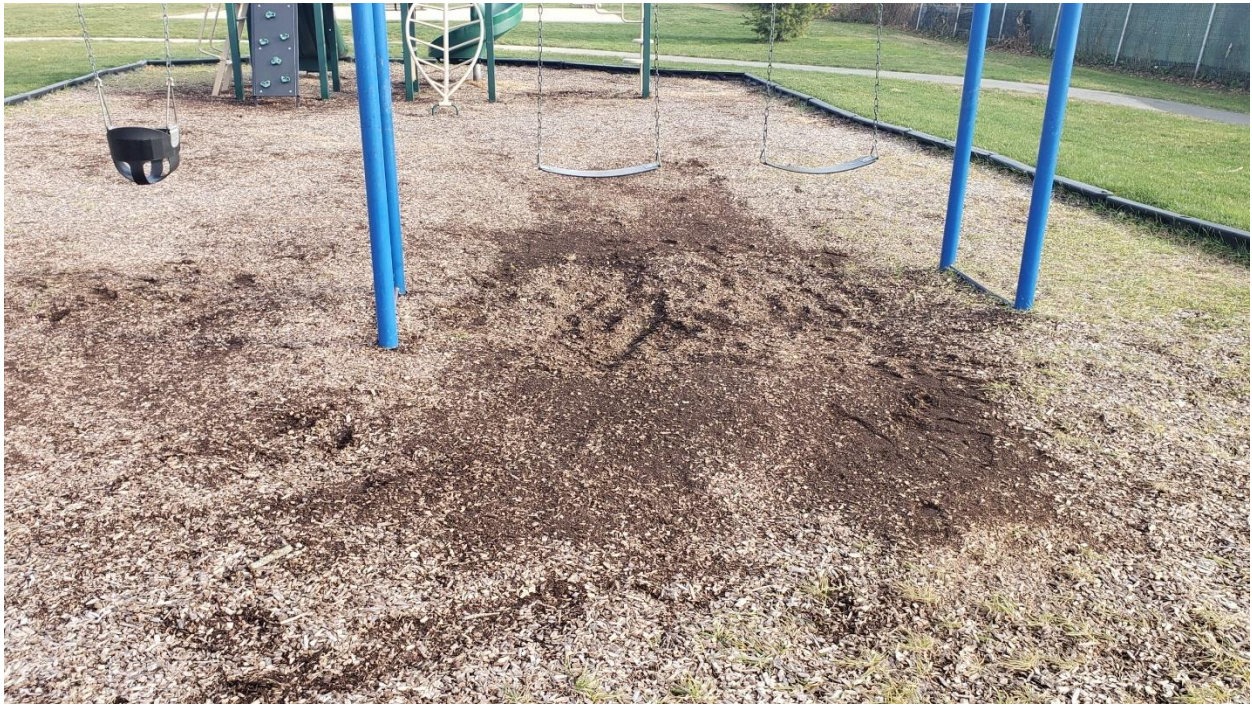
Picture A2 - East Village Park playground, worst case soil exposure, viewed December 2020

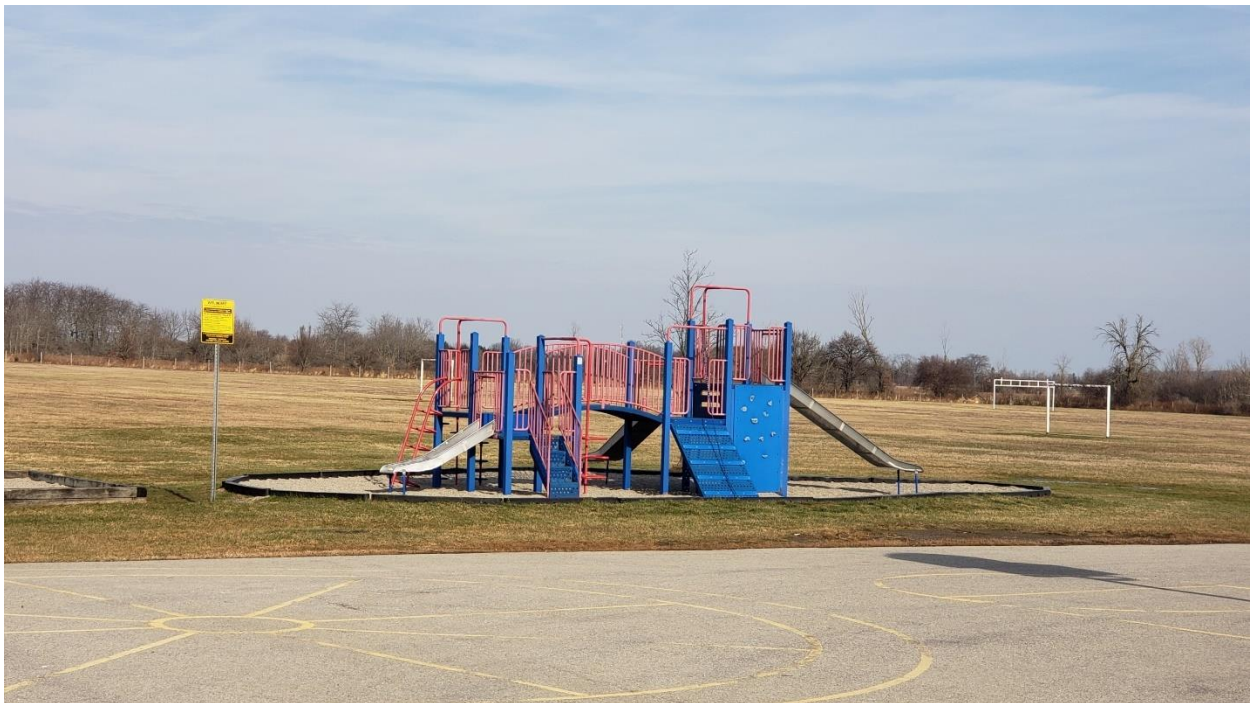
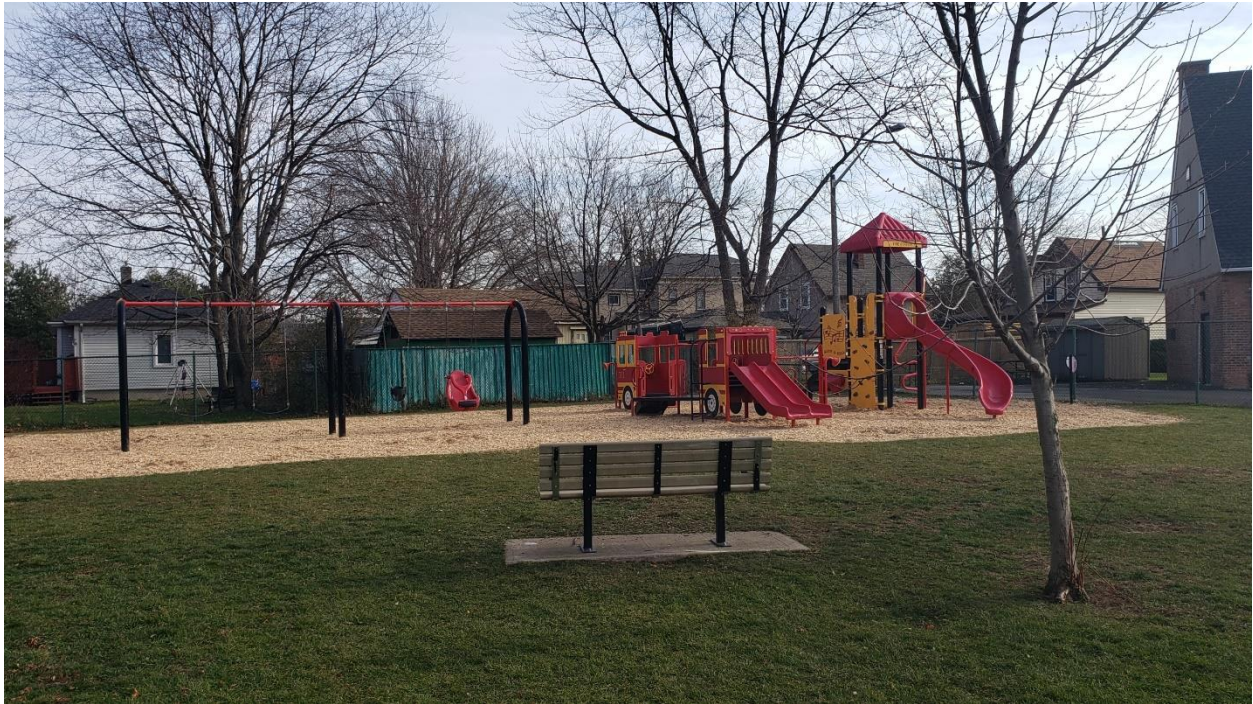
Picture B- Playground serving the elementary grades of DeWitt Carter School.

This playground is located on Fares Street, north of Bell Street. There is a thick layer of woodchips on the playground surface, which appeared to remain intact, not exposing underlying soil at any time that site visits occurred.

The playground is maintained by the school/ grounds maintenance support.

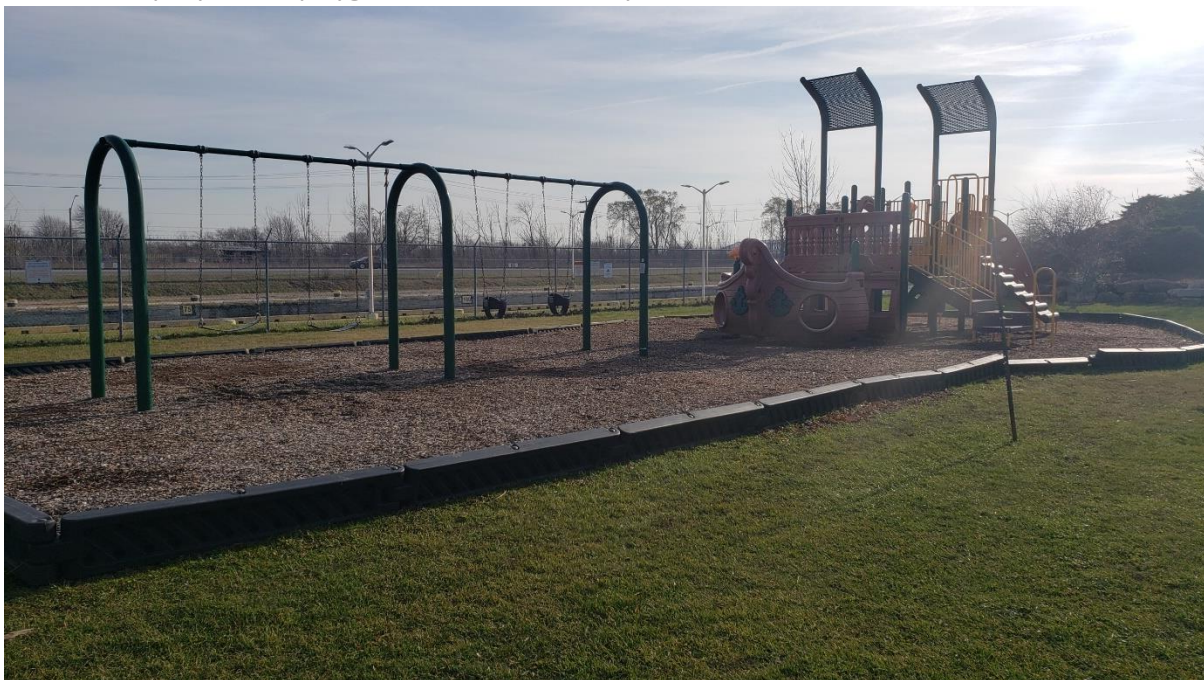
Picture C – Lock 8 Park

This playground is the furthest from Vale, located on Mellanby Avenue, south of Main Street. There is a thick layer of woodchips on the playground surface which, during site visits, was not observed to be disturbed to expose underlying soil. Ruts that were present beneath swings did not penetrate through the woodchip layer. The playground is maintained by the CPC.

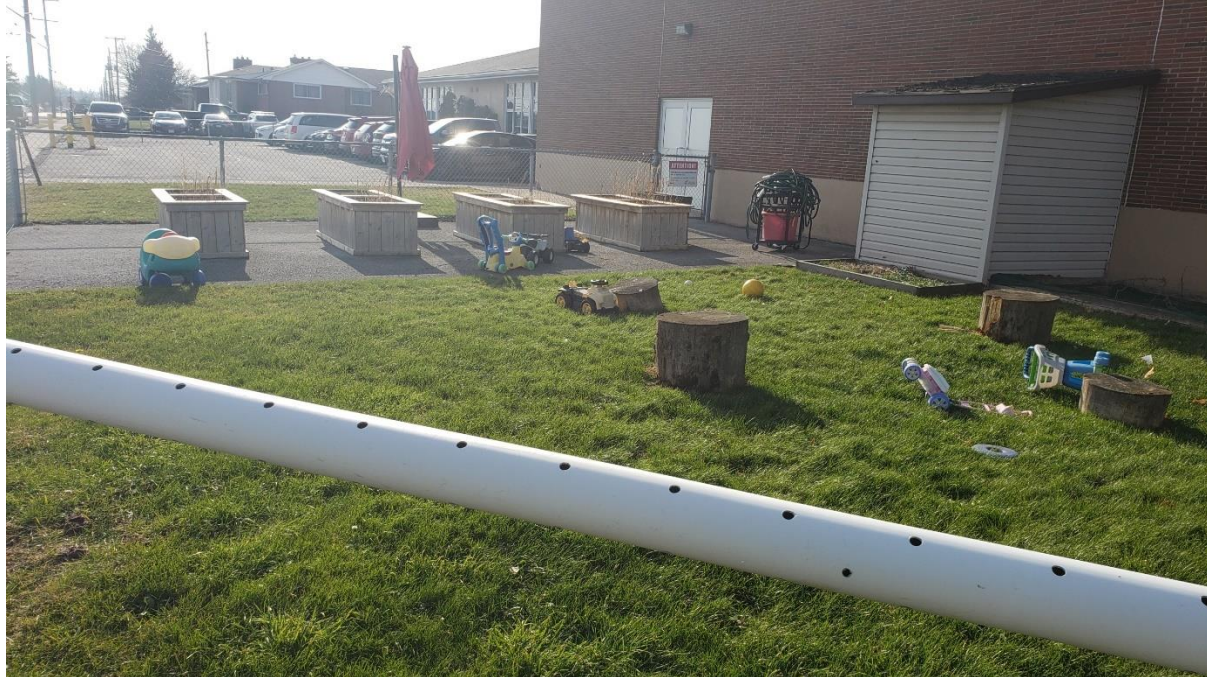
Picture D – Playground for early years children at Ecole Saint Joseph

This playground is located on Elizabeth Street, north of Killaly Street. The playground for elementary students is asphalt paved in some areas, and sod covered on the other half. The playground is maintained by the school/ grounds maintenance support. There was no indication of bare soil exposure in the sod covered area during site inspections.

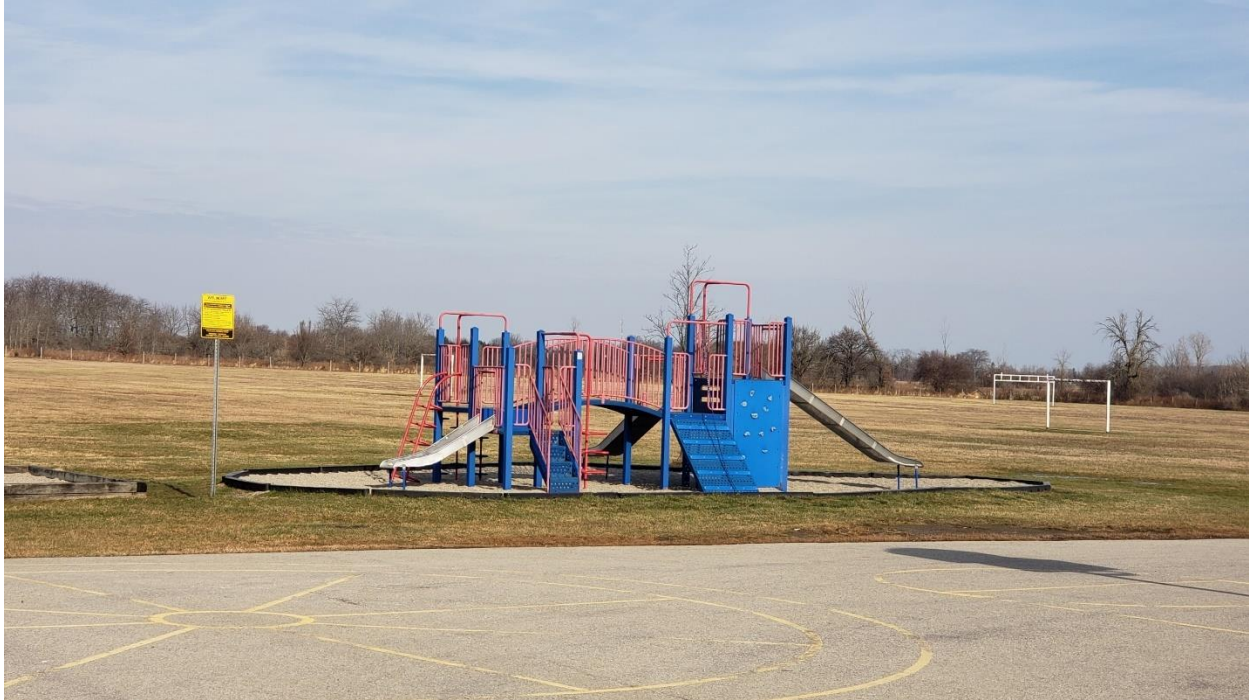
Picture E – Playground for elementary grades at St. Therese School

This playground is located at the rear of the school on Killaly Street, east of James Avenue. There is a thick layer of woodchips on the playground surface, which appeared to remain intact, not exposing underlying soil at any time during which site inspections were made. The playground is maintained by the school/ grounds maintenance support.
